CLAIBORNE COUNTY ADA ASSESSMENT:

GOALS AND PROCEDURES

Facility:
Address:

Claiborne County Courthouse
1740 Main St.
Tazewell, TN 37879

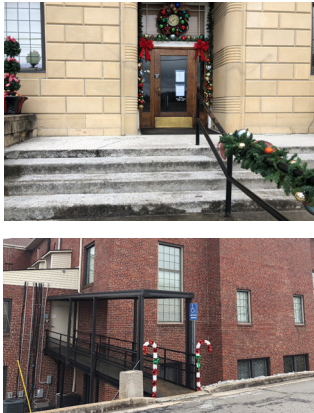
NO.	CONDITION	SOLUTION	CHECKLIST / ADA #	ILLUSTRATION	PHOTOS	ESTIMATED COST
SECTION A: APPROACH & ENTRY						\$4,100.00
A1	The accessible entry to the facility is in the rear of the building on the second floor and there is accessible parking to that entry and there is a sign indicating that this is the accessible entry. There is not a sign at the front entry directing that the accessible entry is on the other side. Note that the elevator in the building that connects to the first floor is accessible from this entry and was checked for compliance.	Provide a directional sign at the front entry indicating that the accessible entry is at the rear.	1.39 / 216.6

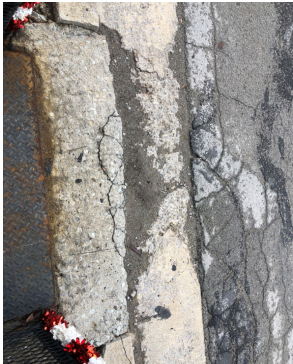
\$100.00
A2	The transition at the bottom of the entry ramp has a bump.	Repair the asphalt to make a smooth transition.	1.13 / 302.1

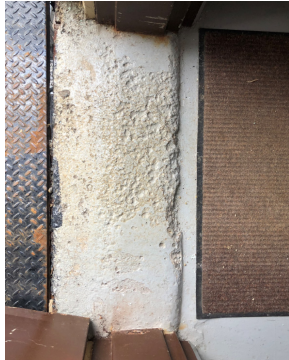
\$1,000.00
A3	The threshold at the accessible entry has a bump.	Repair the concrete to make a smooth transition.	1.43 / 404.2.5

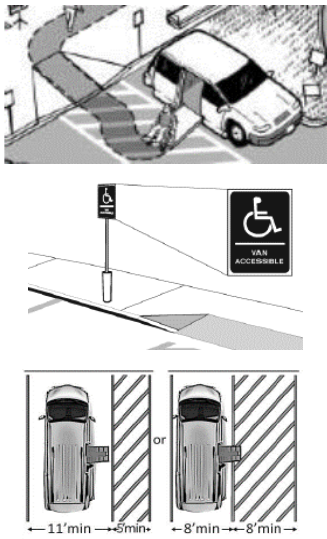
NO.	CONDITION	SOLUTION	CHECKLIST / ADA #	ILLUSTRATION	PHOTOS	ESTIMATED COST
A4	The provided accessible parking is not van accessible.	Provide a van accessible space in an adjacent public lot. Provide "Van Accessible" signage at 60" high.	1.3 / 208.2.4

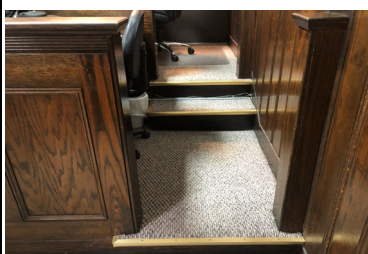
\$4,000.00
B3	Access to judge's stand and jury stands in both courtrooms is through stairs.	Reasonable accommodations in the immediacy for this is to provide a portable ramp that can be stored in a location that it can be easily accessed when needed. When the courtrooms are renovated in the future, provide compliant ramps up to raised areas.	203.9

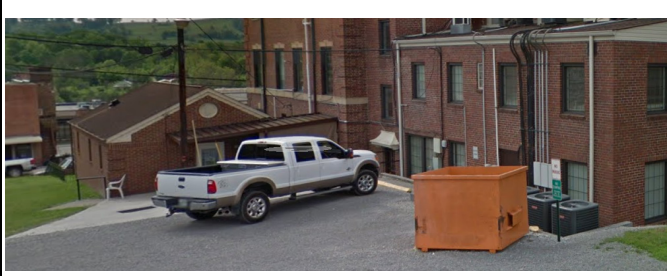
\$100.00
A2	Current accessible entry is through the upper floor at the rear of the Courthouse. Entering this facility through the upper floor of an adjacent facility, then having to take an elevator down, then exit the facility to get to this facility is a convoluted path, and is not workable if the operating hours of the Courthouse are different than that of this facility.	Provide an accessible space in the existing gravel lot, and replace the existing stair from the lot with a ramp.	1.1 / 206.2.1

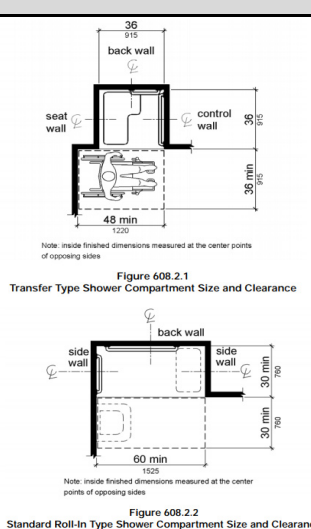
C1	A shower is provided. The shower is not accessible.	Reconfigure restroom (and adjacent storage space if necessary) to include an accessible shower (transfer or roll-in type), taking into account that the toilet needs a 36" grab bar to the side of it. Currently, the toilet has a 24" grab bar to the side.	608.2

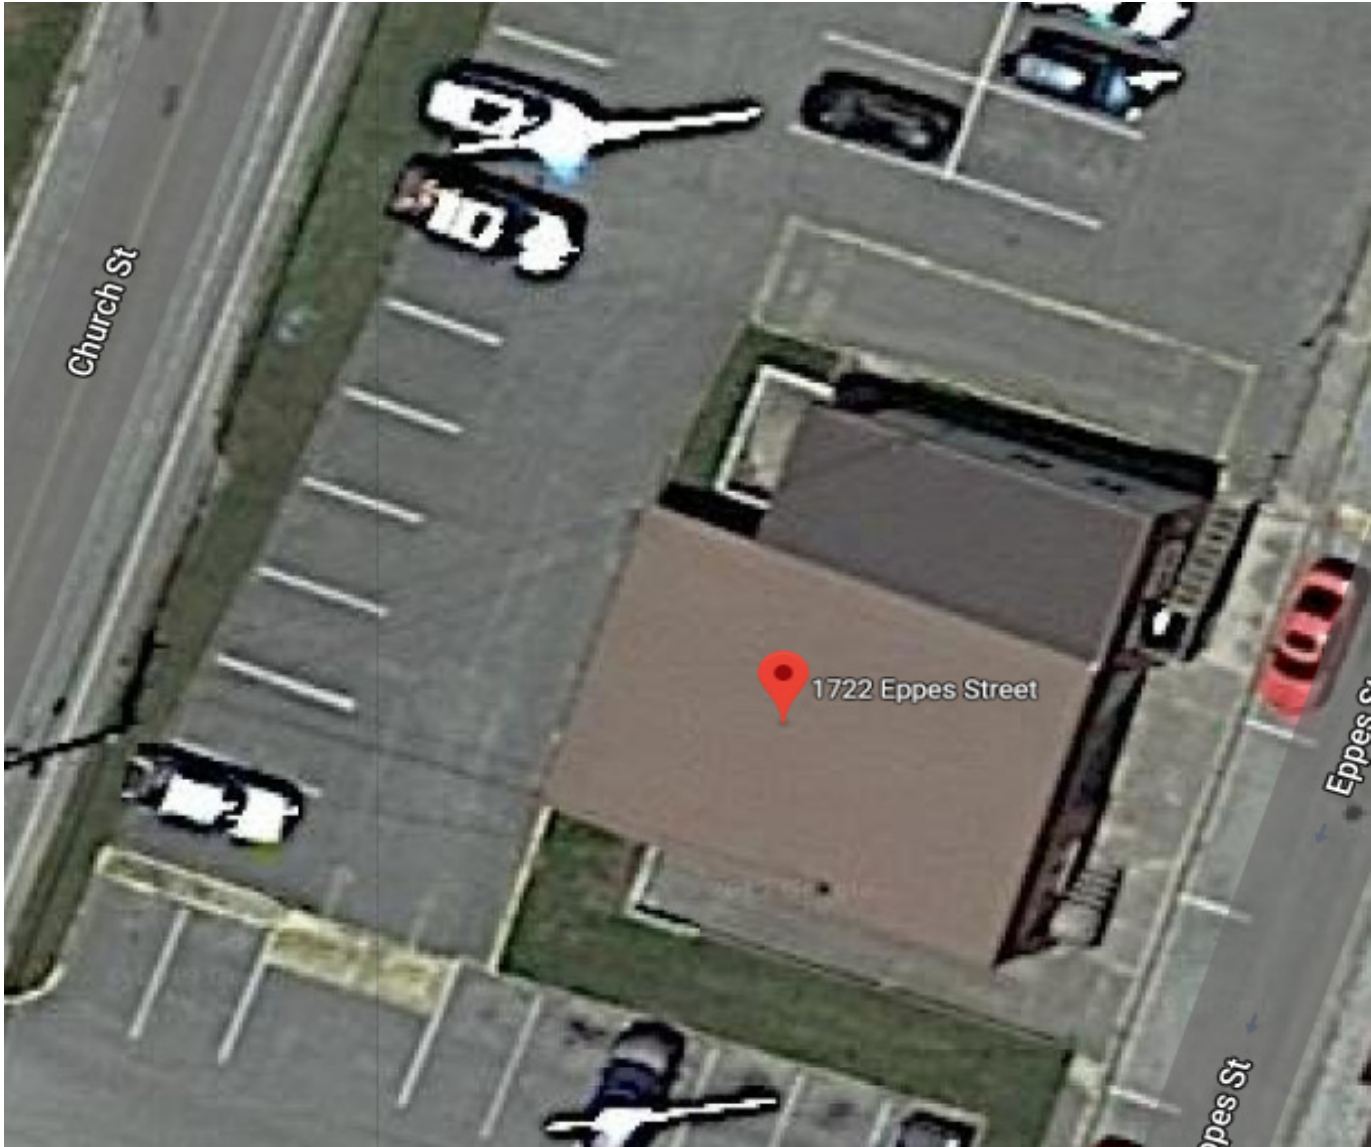
Building Behind Courthouse
1722 & 1726 Eppes St.
Tazewell, TN 37879

This facility is currently not in use. Recommended improvements may change once new use of facility is identified.

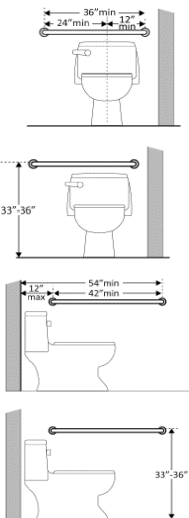
NO.	CONDITION	SOLUTION	CHECKLIST / ADA #	ILLUSTRATION	PHOTOS	ESTIMATED COST
C2	Restroom in 1724 Eppes Street has misplaced grab bars.	Relocate grab bars per ADA.	Section 3 / Chapter 6

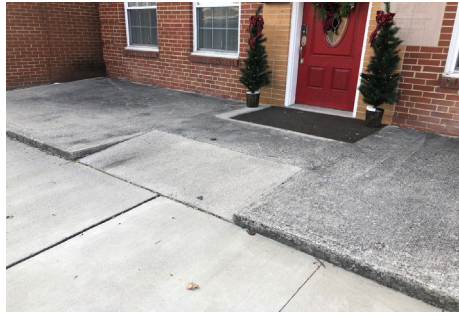
NO.	CONDITION	SOLUTION	CHECKLIST / ADA #	ILLUSTRATION	PHOTOS	ESTIMATED COST
SECTION A: APPROACH & ENTRY						\$0.00
Note	For this facility, the entry is accessed through the front only. Close to this front entry are accessible parallel street spaces that connect to the entry through a curb cut. Note that there is not a "Van Accessible" space but when improvements are made to the Election Commission, there will be a "Van Accessible" space that will be connected to the public right-of-way, which connects to this facility.

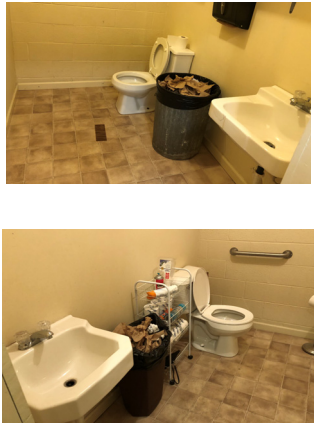
\$2,000.00
C2	Both restrooms need 42" and 36" grab bars. Note that the Women's room has a 24" grab bar.	Provide grab bars per ADA mounting dimensions.	3.33, 3.34 / 604

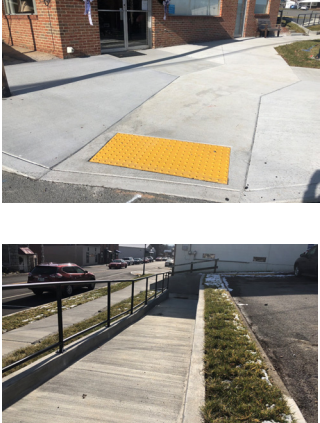
NO.	CONDITION	SOLUTION	CHECKLIST / ADA #	ILLUSTRATION	PHOTOS	ESTIMATED COST
SECTION A: APPROACH & ENTRY						\$14,050.00
A1	<p>Access to first floor: Access is currently provided from the public way by new curb cuts and to a parallel parking space on the street.</p> <p>Access to the first floor can also be with use of the adjacent parking lot. A new ramp to that parking lot has been recently constructed. This ramp has handrails on only one side of the ramp.</p>	Construct a railing on the second side of the ramp.	1.30 / 405.8

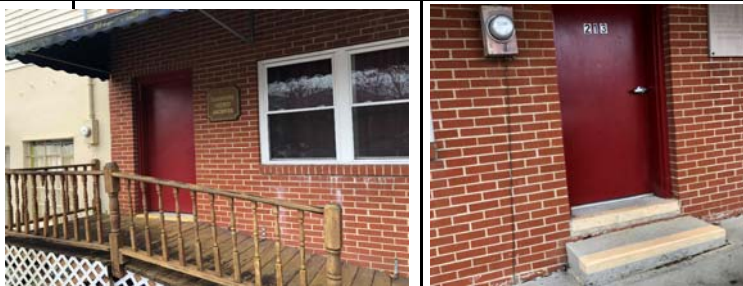
\$2,000.00
A2	The main floor can be accessed through two entries - one with two stairs and one with a ramp that is non-compliant. The ramp lacks a compliant landing and handrails, and is too steep.	Reconfigure one of the entries to be accessible. The entry on the right could be built up to grade and accessed from a new accessible space on the right.

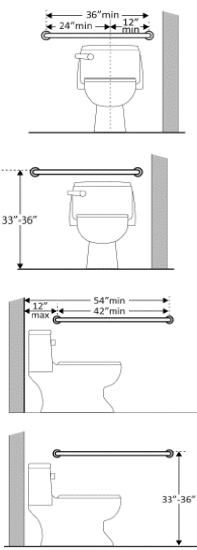
\$1,500.00
C2	Toilet has no grab bars.	Install blocking and a 42" and 36" grab bar per ADA.	3.33, 3.34 / 604.5.1-2, 609.4

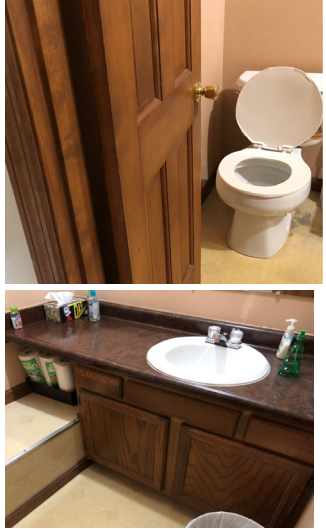
\$10,000.00
SECTION C: RESTROOM FACILITIES						\$8,000.00
C1	Restroom is not accessible.	Provide a unisex accessible restroom. Space will need to be reconfigured to provide clearances. Replace toilet with accessible height toilet, Provide grab bars.	Section 3 / Chapter 6

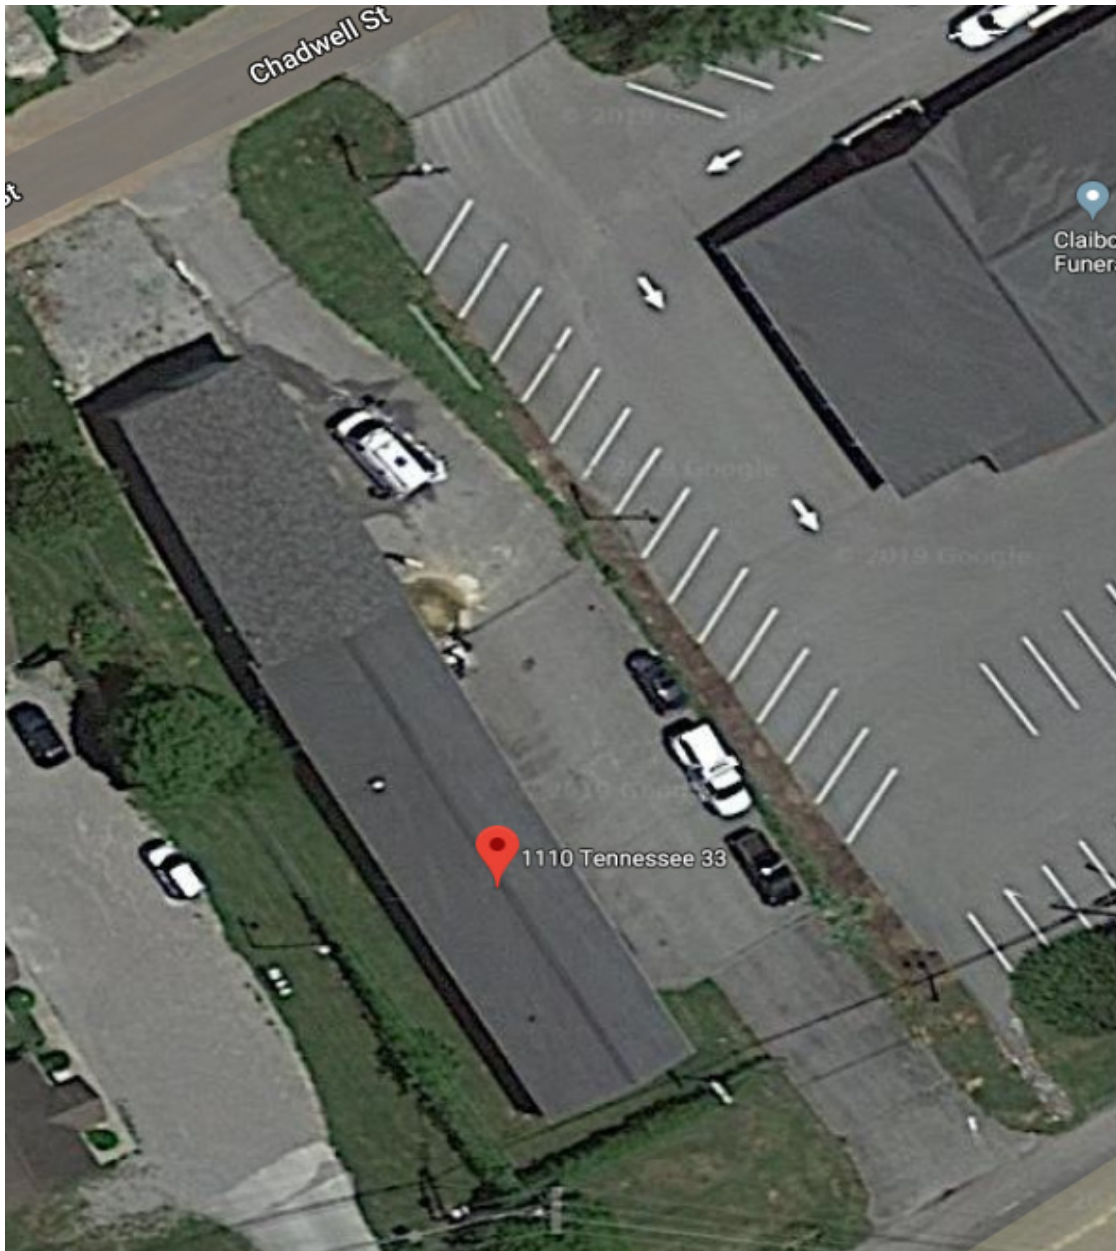
Claiborne County Rescue Squad
1110 Hwy 33 South
New Tazewell, TN 37825

This facility is only used by Active Duty. No public uses this facility. Any disabled Rescuer would not use this facility. No improvements are recommended.

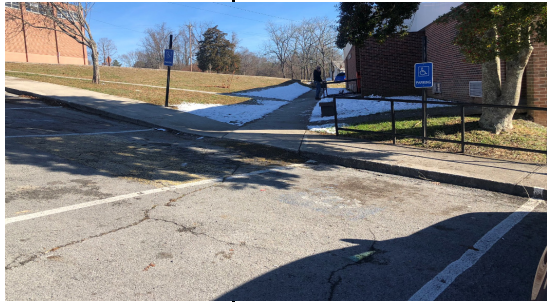
NO.	CONDITION	SOLUTION	CHECKLIST / ADA #	ILLUSTRATION	PHOTOS	ESTIMATED COST
SECTION A: APPROACH & ENTRY						\$18,000.00
A1	Accessible Parking is provided but it is on a steep slope and there is not a "Van Accessible" space.	Demolish portion of asphalt and re-grade accessible spaces. Include a Van Accessible Space. Maximum slope is 1:48 in all directions. Connect aisle to sidewalk with smooth transition.	1.3, 1.8 / 208.2.4, 502.2

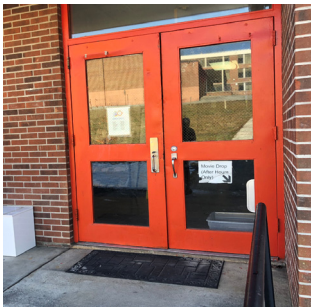
\$15,000.00
A2	The threshold has a small step.	Provide a transition plate or mat.	1.43 / 404.2.5, 303.2

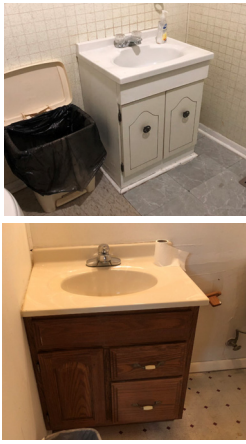
NO.	CONDITION	SOLUTION	CHECKLIST / ADA #	ILLUSTRATION	PHOTOS	ESTIMATED COST
C2	Upper Floor Ladies Room and Lower Floor Men's Room: Lavatory is in a vanity.	Replace with an accessible lavatory with required clear space below. Insulate Pipes at all four lavatories.	3.23 - 3.26 / 306, 606

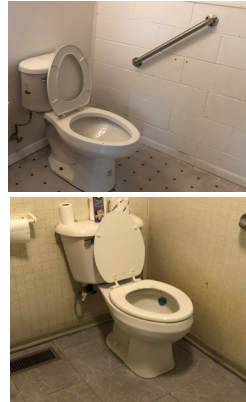
\$2,000.00
C3	Upper Floor Men's and Women's Restrooms - toilets are too close to the adjacent walls. Lower floor Men's and Women's Restrooms - toilets are too far from walls.	Relocate 4 Toilets to be 18" from adjacent walls or relocate / add walls to provide correct dimensions.	3.32 / 604.4

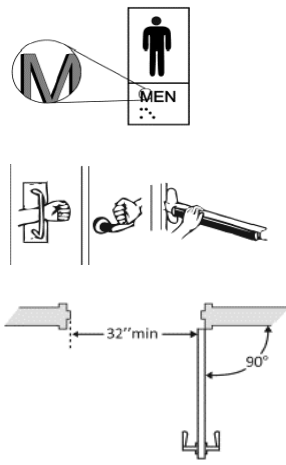
\$6,000.00
C4	Restroom entry at all 4 restrooms: Restroom signage does not contain braille and is at incorrect height. Doors lack 32" clearance and compliant hardware.	Replace 4 signs at 60" high. Re-frame and replace 4 doors with new door hardware.	3.5, 3.7, 3.9 / 703, 404.2.7, 404.2.4

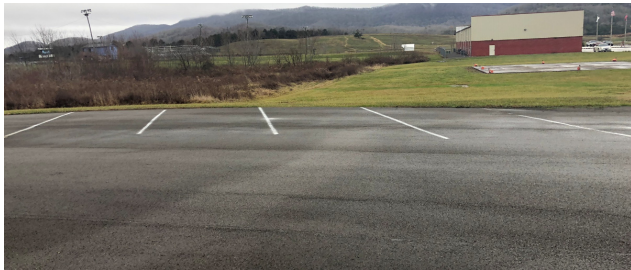
NO.	CONDITION	SOLUTION	CHECKLIST / ADA #	ILLUSTRATION	PHOTOS	ESTIMATED COST									
SECTION A: APPROACH & ENTRY						\$2,300.00									
A1	No accessible parking is provided at the lower floor entry.	At lower and upper floor entries: Provide number of accessible parking spaces as required per total parking count. One space is to be van accessible. Provide signage at parking at 60" high. Provide accessible route from reserved spaces to accessible entry.	1.2, 1.3, 1.5, 1.9, 1.10 / 208.2	<div>

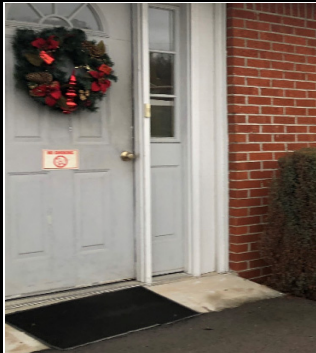
\$100.00									
A3	Entry door hardware is not compliant.	Replace hardware at two entries.	1.17 / 403.3
